**DEPARTMENT OF TRANSPORTATION****DIVISION OF ENGINEERING SERVICES**

Contract #: 04-0120F4Cty: SF/ALA Rte: 80 PM: 13.2/13.9File #: 1.28**WELDING INSPECTION REPORT****Resident Engineer:** Pursell, Gary**Address:** 333 Burma Road**City:** Oakland, CA 94607**Report No:** WIR-013197**Date Inspected:** 21-Apr-2010**Project Name:** SAS Superstructure**OSM Arrival Time:** 630**Prime Contractor:** American Bridge/Fluor Enterprises, a JV**OSM Departure Time:** 1500**Contractor:** American Bridge/Fluor Enterprises, a JV**Location:** Job Site**CWI Name:** Jim Cunningham, Steve McConnell, CWI Pres. D. Cerna**Yes No****Inspected CWI report:** Yes No N/A **Rod Oven in Use:** Yes No N/A**Electrode to specification:** Yes No N/A **Weld Procedures Followed:** Yes No N/A**Qualified Welders:** Yes No N/A **Verified Joint Fit-up:** Yes No N/A**Approved Drawings:** Yes No N/A **Approved WPS:** Yes No N/A**Delayed / Cancelled:** Yes No N/A**Bridge No:** 34-0006**Component:** SAS OBG 2W/3W-D, 3W/4W-D,**Summary of Items Observed:**

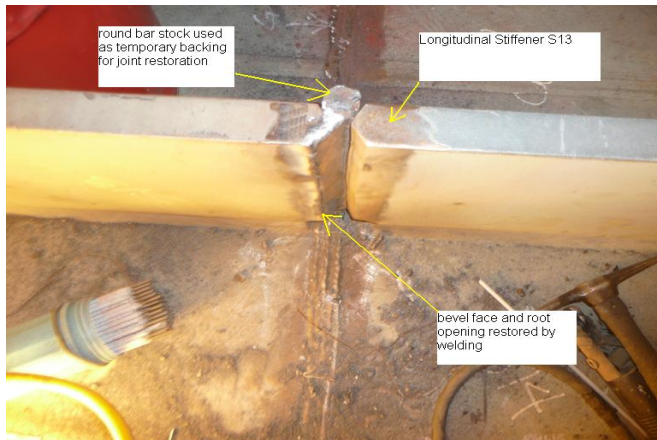
The QA Inspector randomly observed the ABF welder Jordan Hazelaar performing shielded metal arc welding (SMAW) joint restoration or butter passes in the vertical position. The QA Inspector noted, due to the fit up of the 1W/2W orthotropic box girders, the root openings of the stiffeners were excessive. The QA Inspector noted 7mm maximum allowed root opening and most of the root openings were in excess of 13-14mm. The QA Inspector observed the contractor has elected to perform joint restoration to restore the root openings and bevel angles to the original joint configuration. The QA Inspector randomly observed the ABF welder had installed round bar stock in the double V-groove opposite the side where joint restoration is being performed (pictured below). The QA Inspector noted the round bar stock is place in the groove vertically and SMAW butter passes are perform on the opposite side. The QA Inspector noted once the weld joint has been restored to the original joint configuration, the round bar stock will be removed and welding can be performed as described in the approved WPS identified as ABF-WPS-D1.5-2010-C. The QA Inspector randomly observed the above identified welder was performing SMAW butter passes on all three of the above identified weld joints during the QA Inspectors shift. The QA Inspector randomly observed the ABF welder to be utilizing 1/8" E7018 low hydrogen electrodes with 135 Amps. The QA Inspector noted the SMAW parameters appeared to be in general compliance with the contract requirements.
